Vehicles affected: All Models

Location: Chassis - Steering

Concern: Steering Column does not move and/or does not calibrate

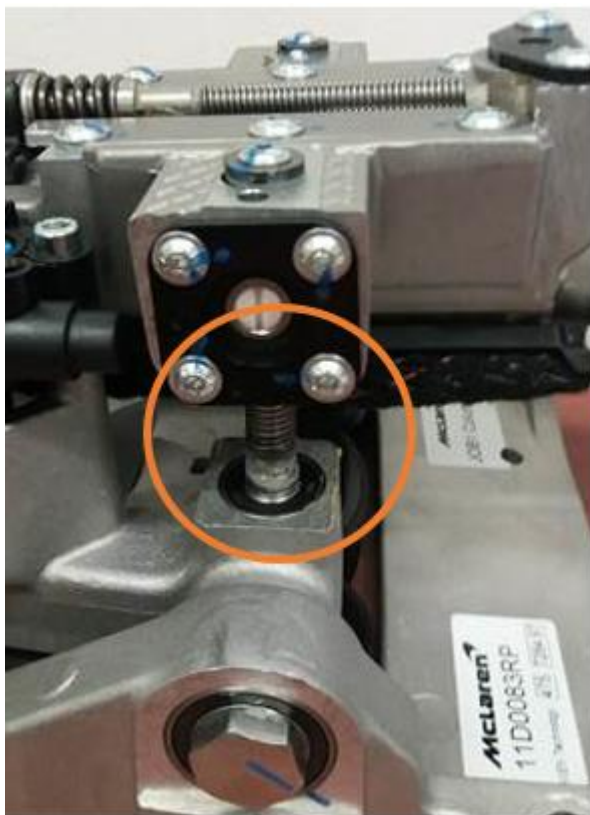
The steering column can sometimes overdrive and get stuck on the end stop position. The image below demonstrates this.

(For demonstration purposes, the steering column is removed from the vehicle)

If the above has occurred, it can be identified by the steering column being in either full reach or rake position, not moving during the calibration and potentially be able to hear the motor attempting to drive the column but after 2 to 3 attempts it will stop.

To overcome this, manually assist the movement of the steering column in the opposite direction.

- If the steering column is stuck down, you will need to pull the steering column upwards – this will require reasonable force until the column begins moving again.

- If the steering column fails to move after attempting to assist it manually and the calibration has failed, it is likely to be stuck at the end stop. In this instance, you will need to power the correct motor to drive the column off the end stop. Depending on what position the motor has failed will determine which way the motor needs to drive. The motor can be driven in two directions depending on what polarity you supply the voltage.

1. To move the Steering Column Rake (Up and Down), disconnect IMBFC2-M and apply 12V and a Ground to PIN 5 and 13
  2. To move the Steering Column Reach (Forward and Back), disconnect IFCSC1-M and apply 12V and a Ground to PIN 14 and 15

- Once the column has moved off the end stop, run the calibration sequence again.
